**DEPARTMENT OF TRANSPORTATION**

Contract #: 04-0120F4Cty: SF/ALA Rte: 80 PM: 13.2/13.9File #: 69.28**WELDING INSPECTION REPORT****Resident Engineer:**Siegenthaler, Peter**Address:** 333 Burma Road**City:** Oakland, CA 94607**Report No:** WIR-018311**Date Inspected:** 24-Nov-2010**Project Name:** SAS Superstructure**OSM Arrival Time:** 700**Prime Contractor:** American Bridge/Fluor Enterprises, a JV**OSM Departure Time:** 1900**Contractor:** Zhenhua Port Machinery Company, Ltd (ZPMC), Changxing Island **Location:** Shanghai, China**CWI Name:** Xu tao**CWI Present:** Yes No**Inspected CWI report:** Yes No N/A**Rod Oven in Use:** Yes No N/A**Electrode to specification:** Yes No N/A**Weld Procedures Followed:** Yes No N/A**Qualified Welders:** Yes No N/A**Verified Joint Fit-up:** Yes No N/A**Approved Drawings:** Yes No N/A**Approved WPS:** Yes No N/A**Delayed / Cancelled:** Yes No N/A**Bridge No:** 34-0006**Component:** OBG Components**Summary of Items Observed:**

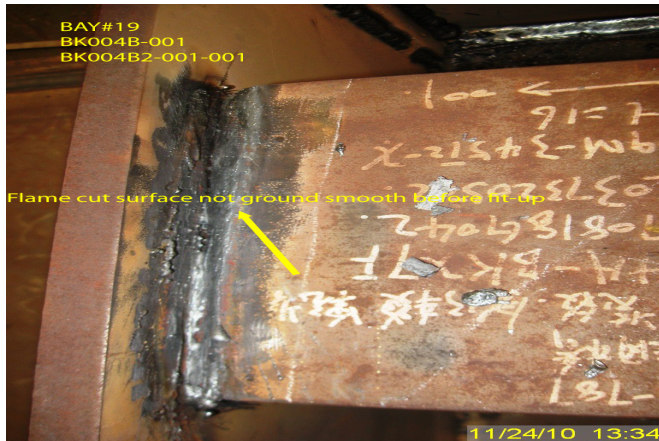
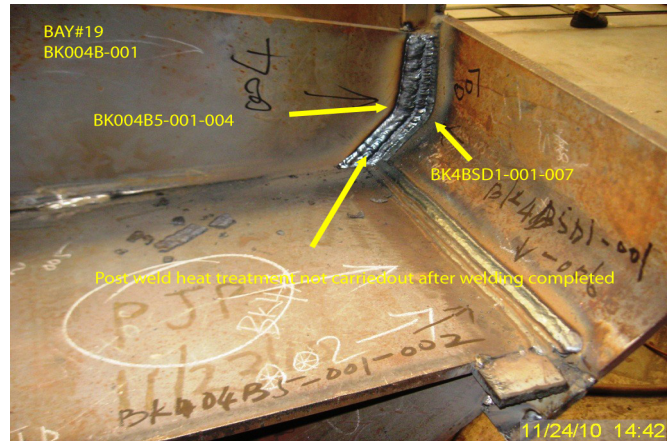
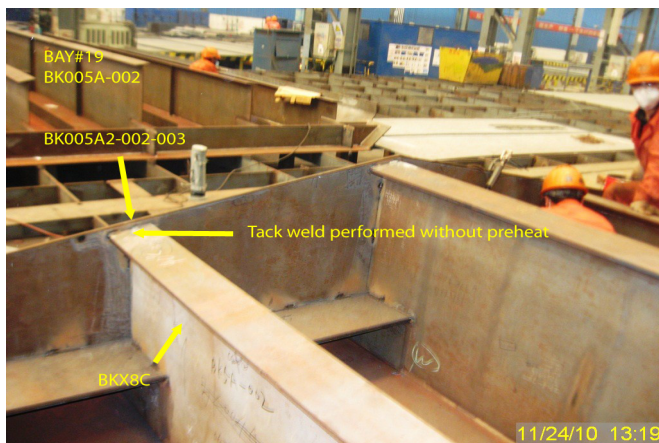
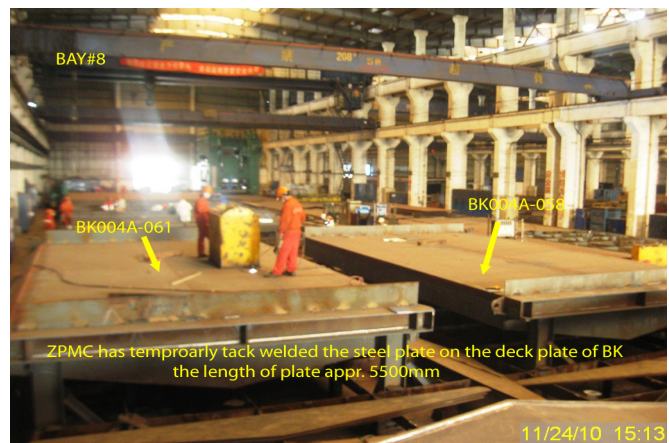
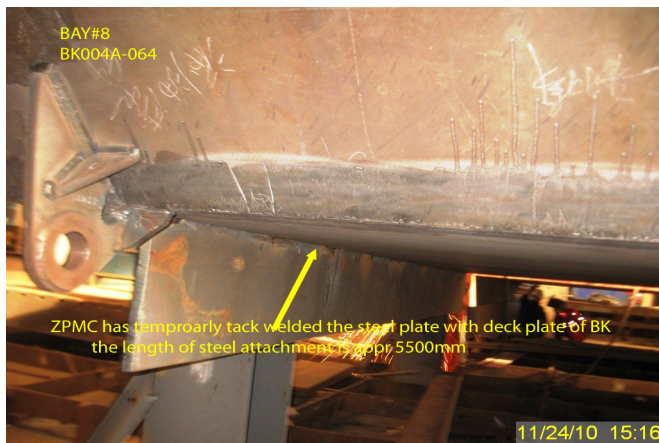
-ZPMC has temporarily tack welded steel plates on top of the Bike path. The Bike path is identified as; BK004A-056, BK004A-061, BK004A-058, BK004A-064, BK004A-057. Total of two (w) steel plates was welded as temporary attachments with the both end of top plate of Bike Path. The approved shop drawings do not specify any welds in these locations. The length of the temporary steel attachment apprx.5500mm in length. The additional material and welding was not approved by the engineer.

BK004B2-001-001,007. Assembly not as per procedure.

BK004B5-001-004 & BK4BSD1-001-007. Post weld heat treatment not followed.

The area was not being preheated.
